PROPERTY CONDITION ASSESSMENT
OF
WORLD TRADE CENTER PORTFOLIO

ONE WORLD TRADE CENTER

Merritt & Harris, Inc. Project Number 20-251E

December 6, 2000

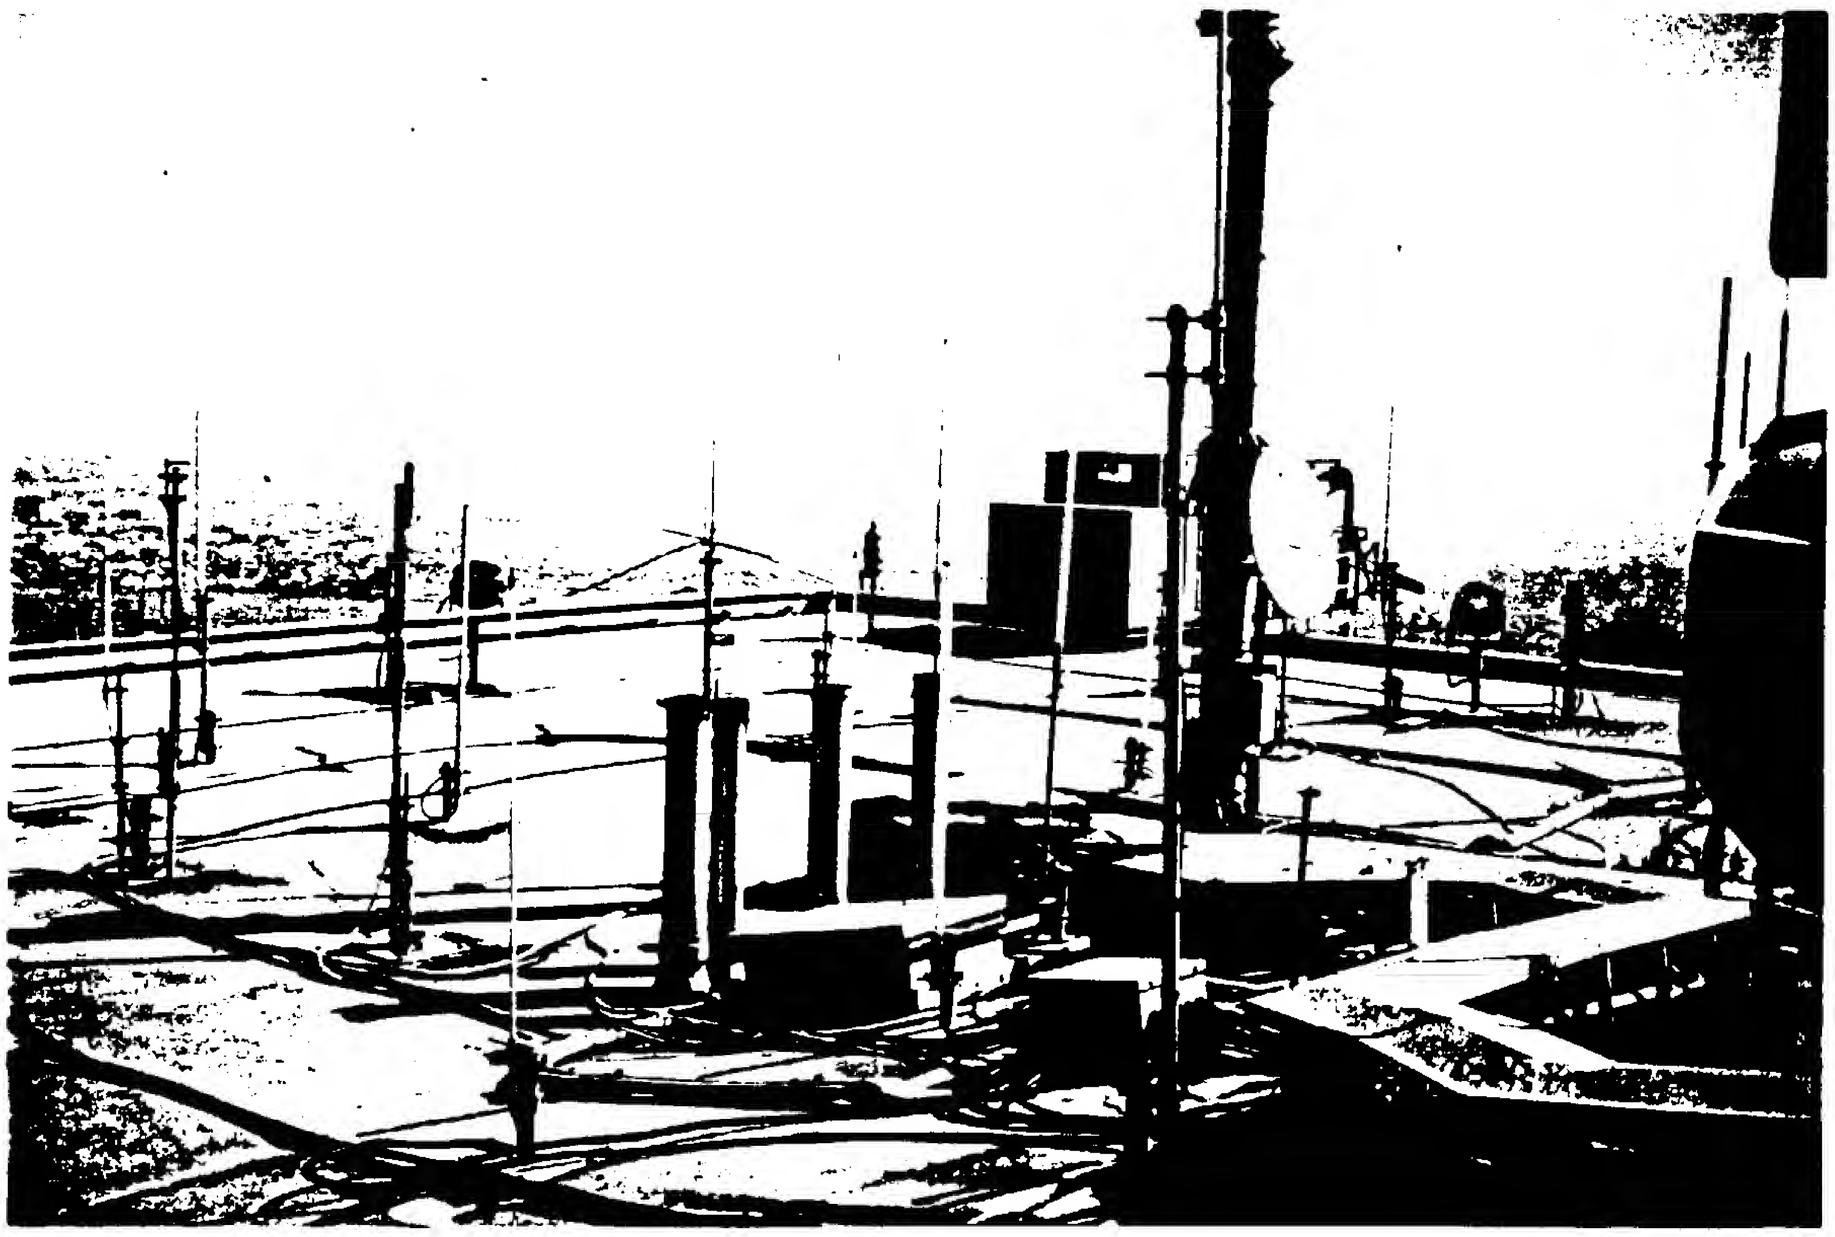
Photo #4: Roof – One World Trade Center.

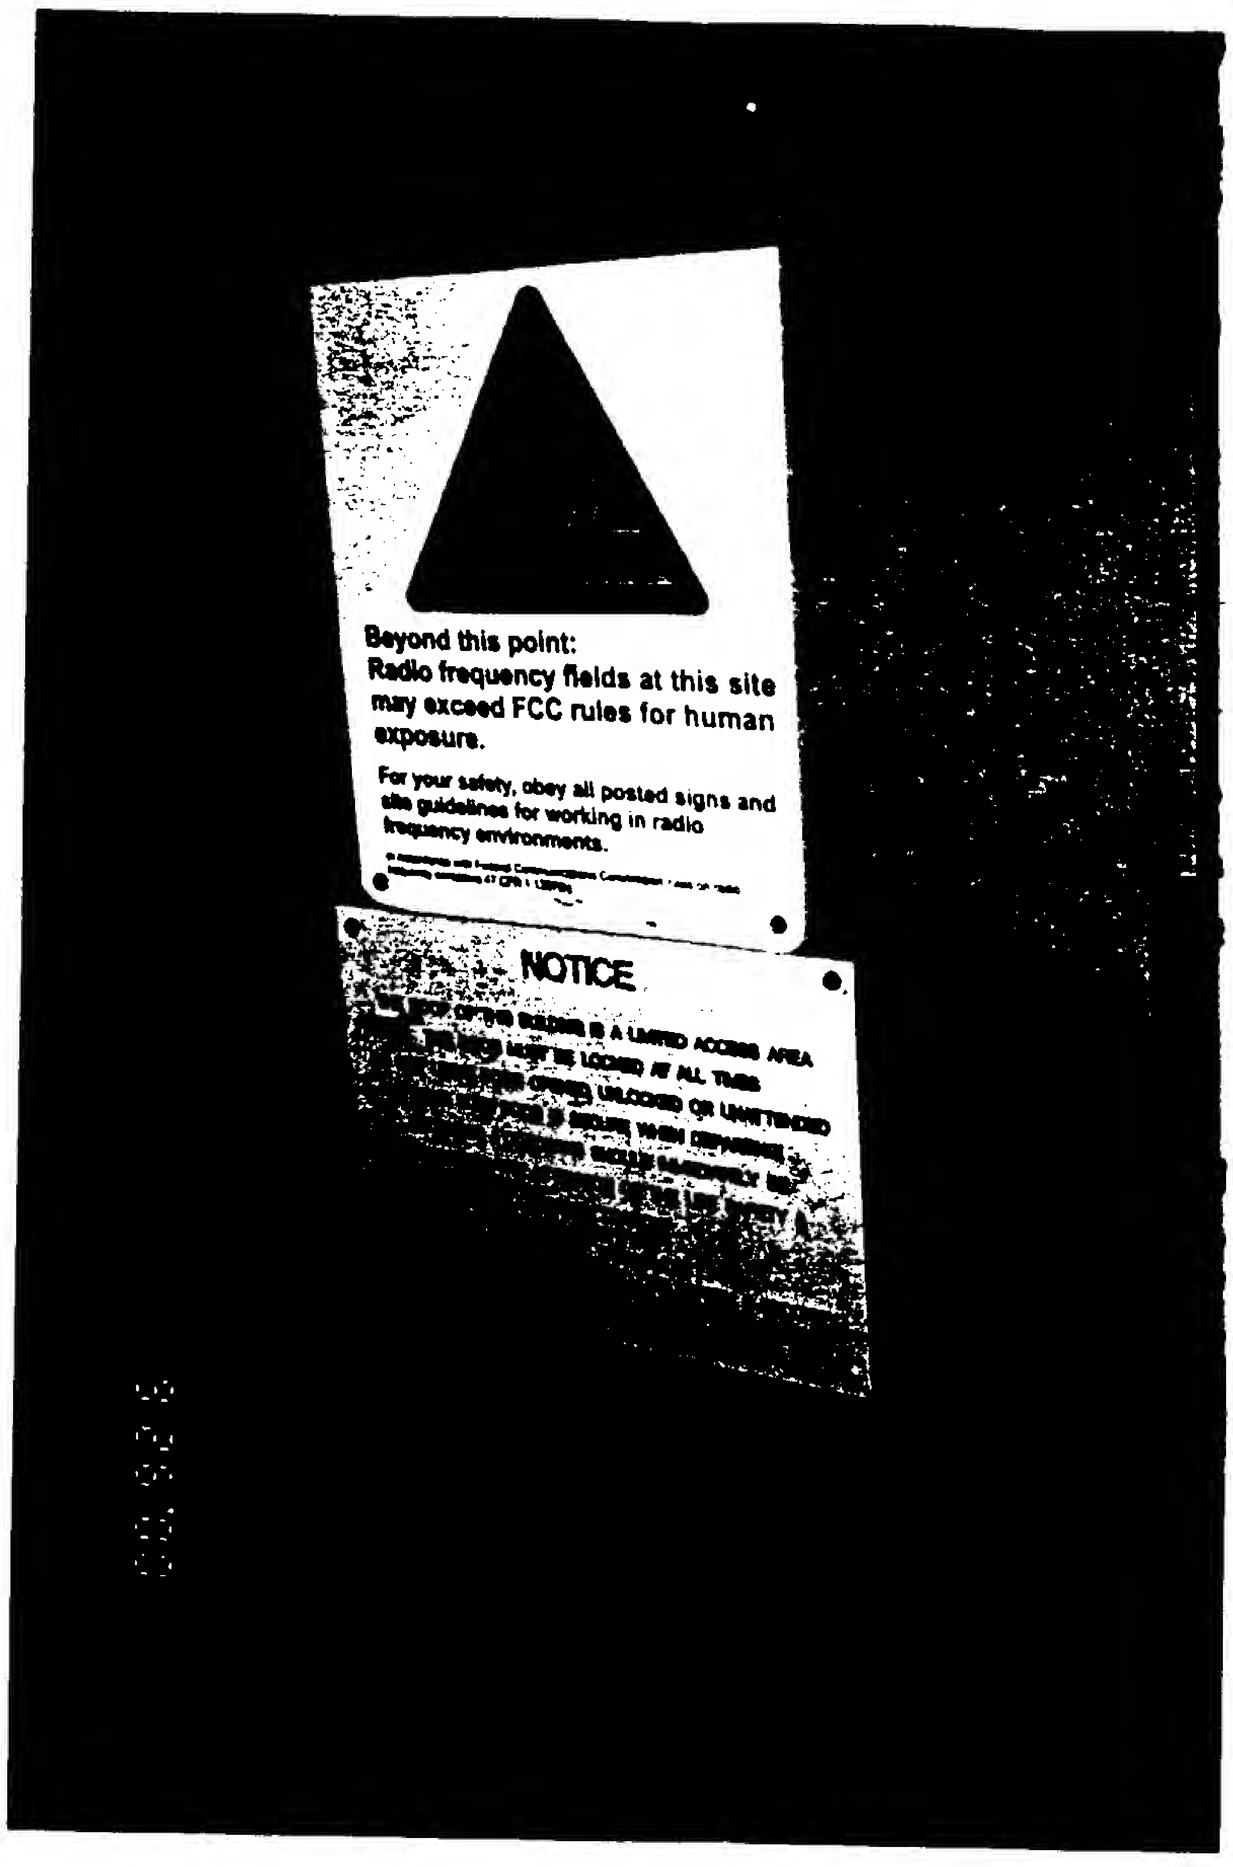
Photo #5: Signage at door to roof – One World Trade Center.
